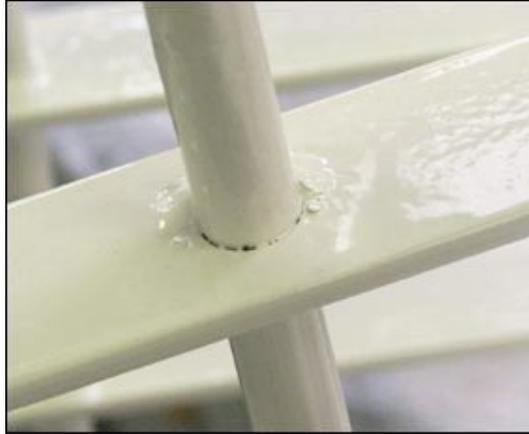
Water Traps

The railing shown was not welded on the top of the upright. Although we have applied over 200 microns of paint in this area in order to fill the gap, we have not been totally successful. Water will flood and remain in the dark areas shown, and because there is no paint will rust quickly. On design and manufacture, all water traps should be avoided. This job could have been hot dip galvanized; the zinc would have filled the cavity.

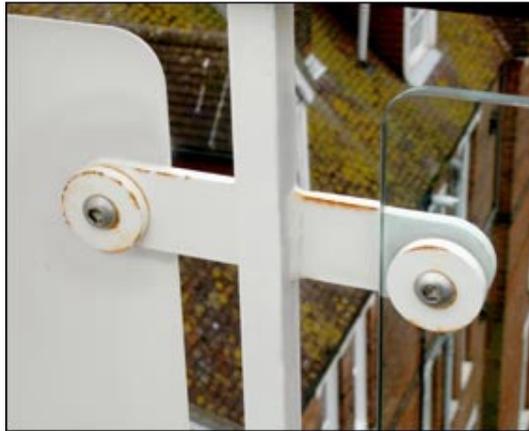
Sharp Edges

Rust was beginning to show. Two problems, generated by the desire to have a smooth finish; the material was not galvanized which is advisable when requiring white, as a pinhead of rust will leave large brown stains on a contrasting background. The second problem was the use of bright steel, which has sharp edges. It can be seen that only these edges are failing, not the flat areas. **Powder wraps very well round curves but it does not cover well over spikes and sharp edges**

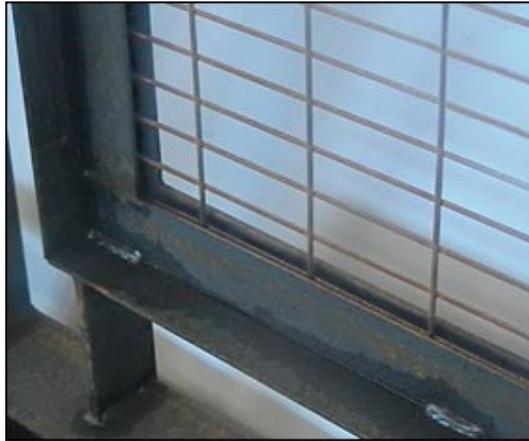
Securing Mesh

The mesh has been trapped between the inside flat of an angle iron and a strap. This has presented us with two problems. We cannot get paint between the two flats and around the mesh, and a water trap has been generated. Water will collect in these areas and without any paint will definitely rust, in a matter of weeks. We would expect brown rust marks to run over the fresh paint. Shortly after the paint will begin to lift as the rust will creep underneath.

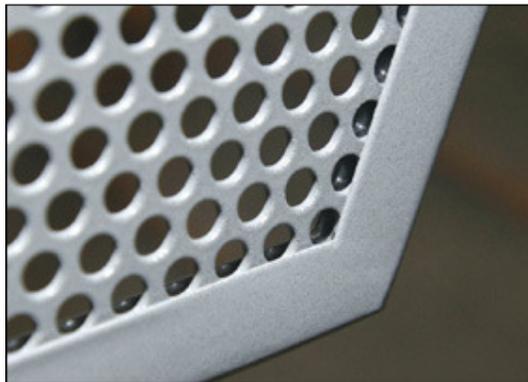
Perforated Sheet

This is a popular design for fixing perforated sheet. However it is a very bad design for avoiding corrosion.

The visible area of perforated sheet will be well protected; however the inner face of the folded edging will start to go rusty in a matter of weeks.

On close observation it can be seen that it is not painted. This is because there is no practical way of getting the paint in there, leaving it with no protection. To compound the problem, water will fill the bottom edging. Within a year, this may need replacing. If this is an obligatory design, stainless steel should be used with drain holes. Once painted introduce oil, or wax oil, this will help protect the un-painted areas

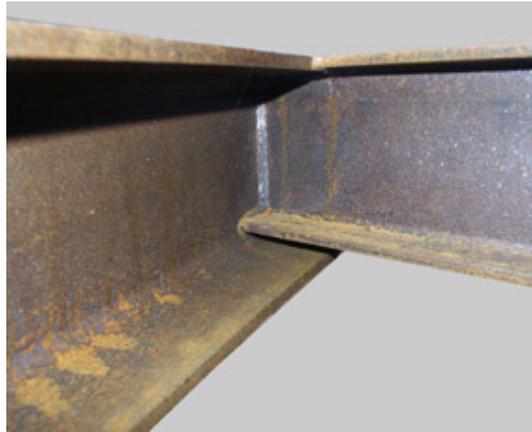
No Paint, No protection

It is important to consider corrosion protection during the design stage. Where there is no paint there will be no protection. This area of overlap could have easily been remedied by using the same size channel or removing the bottom web and fully welding.

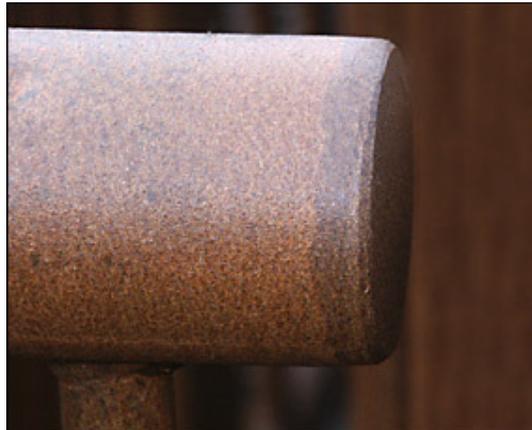
Sharp Edges Should Be Rounded

All painting systems whether it be wet paint or powder coating are more vulnerable on sharp edges because at these points it is usually a thinner coat. On the picture the fabricator has removed the sharp edges on the end of this balcony. A large radius is not required as long as the paint film is uniform thickness, which is not possible on a knife-edge.

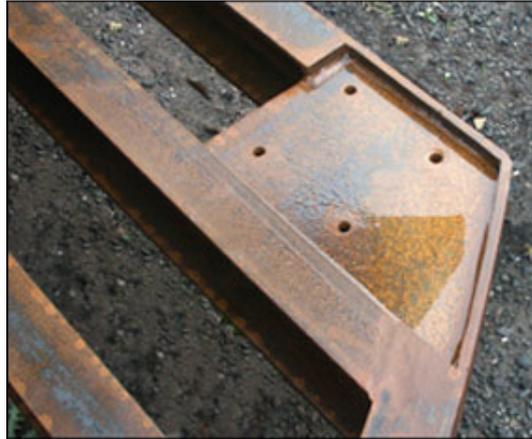
Water Traps

As with the picture above, if it is wet, it is more vulnerable to corrosion. This balcony platform has been manufactured with a water trap. It will stay wet for most of its life. To make matters worse it will have a square foot plate from a post bolted on to it. This will mean the water will be sandwiched between two plates. A bad situation for a structural fixing.

Place a layer of sealant between the two surfaces after painting. Thick grease will last many years repelling the water.
